Port of Salalah, Oman

Crane Structure Cracks

Repair QA Report

Crane No. QC09

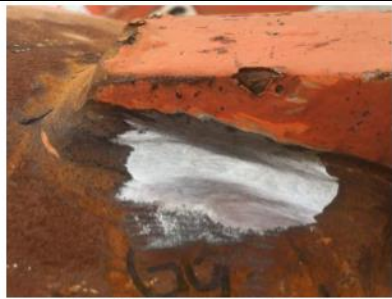
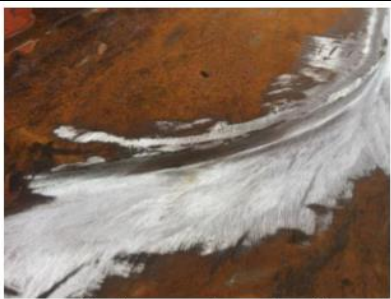
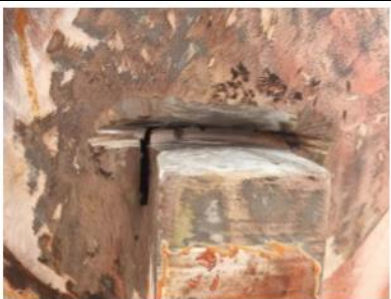
Crack removal inspection-1	Crack removal inspection-1	Crack removal inspection-3

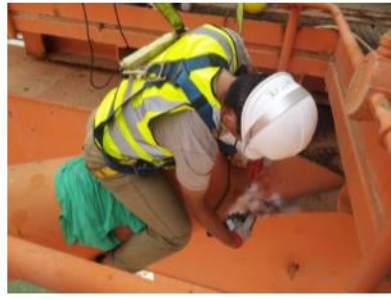
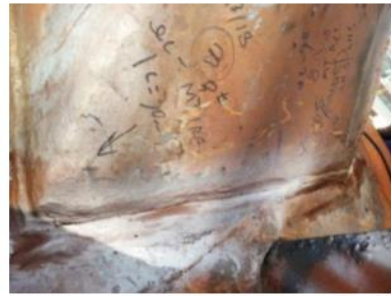
Crack removal DNT inspection-1	Crack removal DNT inspection-2	Crack removal DNT inspection-3

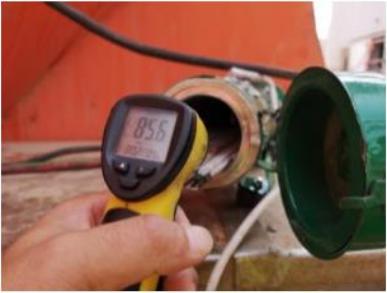
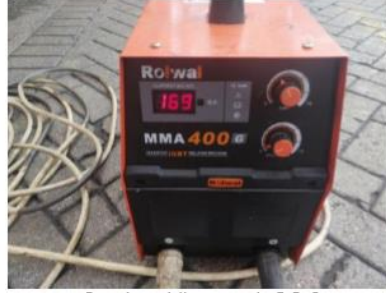
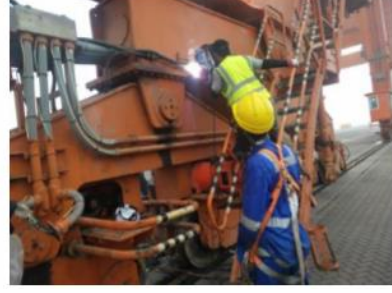
<p><i>Crack repair welding QC-1</i></p>	<p><i>Crack repair welding QC-2</i></p>	<p><i>Crack repair welding QC-3</i></p>

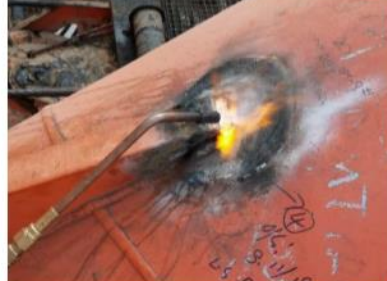
<p><i>Welding repair heating treatment QC-1</i></p>	<p><i>Welding repair heating treatment QC-2</i></p>	<p><i>Welding repair heating treatment QC-3</i></p>

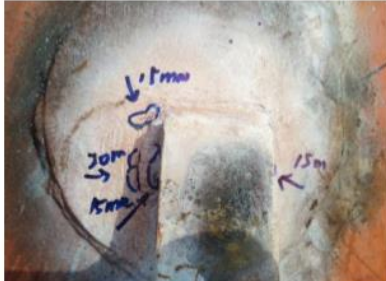
<p><i>NDT inspection after repair-1</i></p>	<p><i>NDT inspection after repair-2</i></p>	<p><i>NDT inspection after repair-3</i></p>

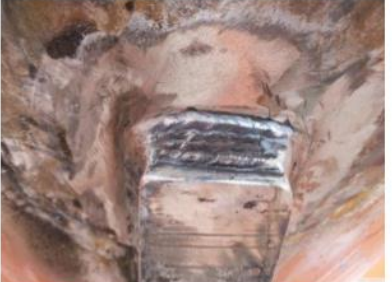
<p><i>Cleaning before paint repair-1</i></p>	<p><i>Cleaning before paint repair-2</i></p>	<p><i>Cleaning before paint repair-3</i></p>

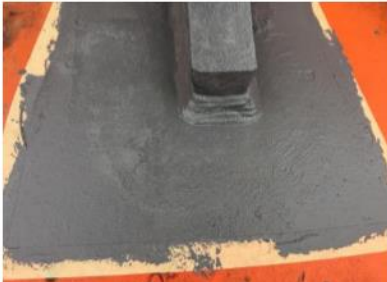
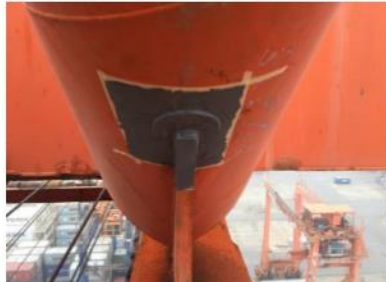
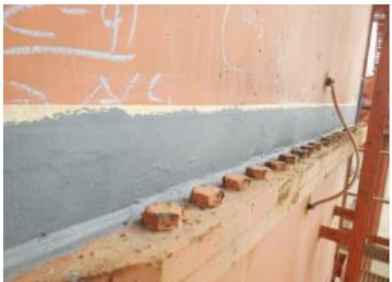
<p><i>Primer paint repair-1</i></p>	<p><i>Primer paint repair-2</i></p>	<p><i>Primer paint repair-3</i></p>
