## **Port of Salalah, Oman**

### **Crane Structure Cracks**

### **Repair QA Report**

**Crane No. QC08**

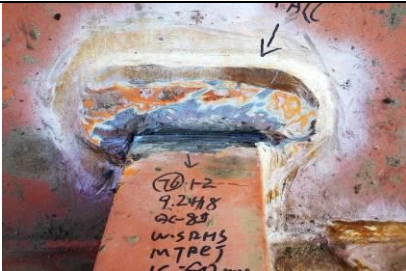
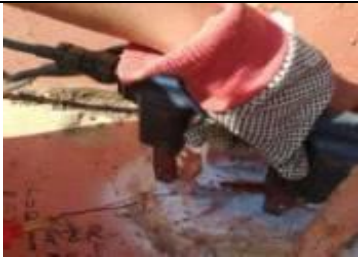
VT inspection after crack removed by grinding	MT inspection after crack removed by grinding	MT inspection after crack removed by grinding

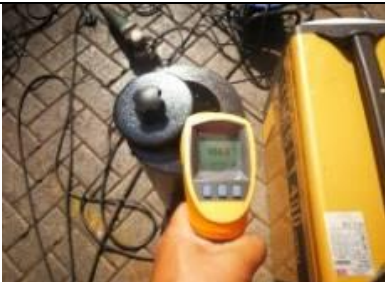
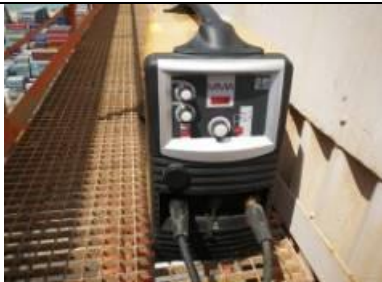
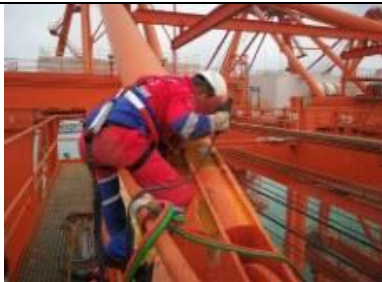
Welding consumable temperature have been checking	Welding data of welding machine have been monitoring	Crack repaired by welding repairing in progress

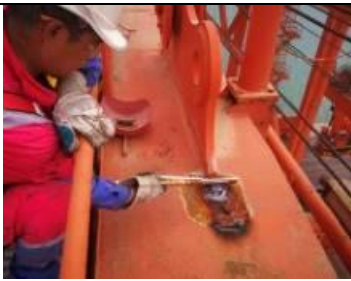
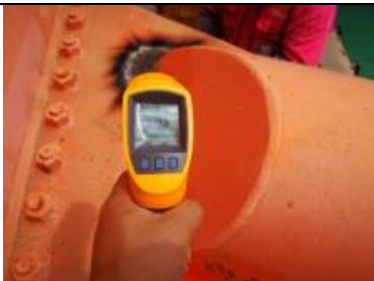
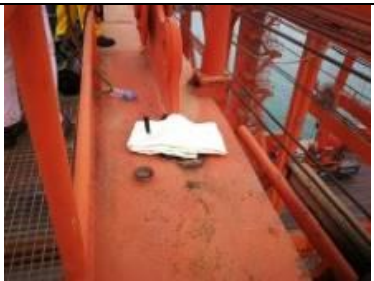
<i>Preheating treatment before welding repairing</i>	<i>Preheating treatment before welding repairing</i>	<i>Re-heating treatment after welding repairing</i>

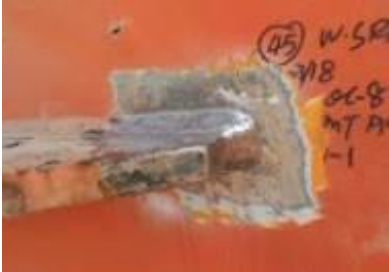
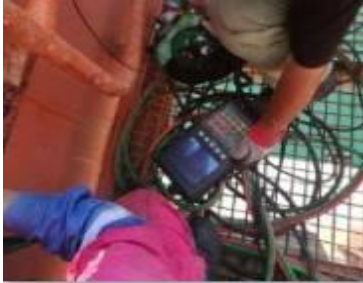
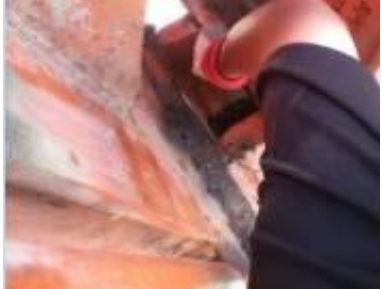
<i>VT inspection after crack repaired by welding repairing</i>	<i>MT inspection after crack repaired by welding repairing</i>	<i>MT inspection after crack repaired by welding repairing</i>

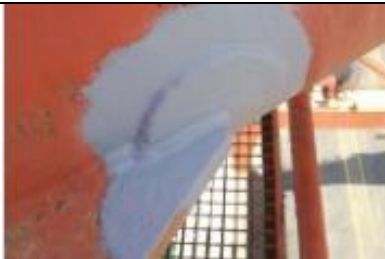
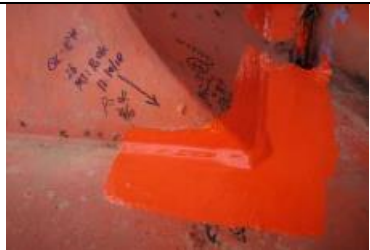
<i>Surface preparation inspection before primer</i>	<i>Surface preparation inspection before top coating</i>	<i>Final inspection after top coating.</i>
