## **ITS TERMINAL PACECO CRANE INSPECTION FORM** **MONO-BOX**

Crane serial Number: Crane 14 Leg Raise Outreach 177.2 ft Back Reach 75 ft Rail Span 100 ft

Inspected By: Scott Tucker Tucker's Technical Services

Date of Inspection: April 5,2022

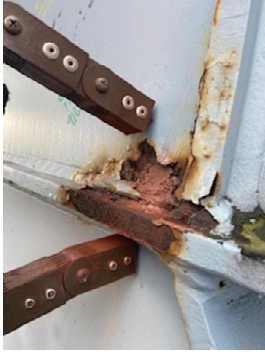
<p>J21-J24</p>

<p>Four corner connection gusset plate heavy corrosion</p>
<p>A-Frame Support Lower</p>

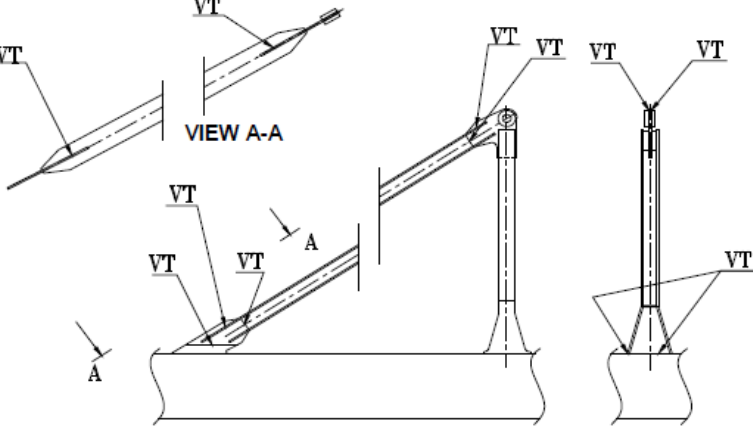
<p>J42-J43 Back stay foundation welds Need weld repair</p> <p>Man hole next to back stay Attachment weld needs repair- WELD REPAIRED 10/12/22</p>

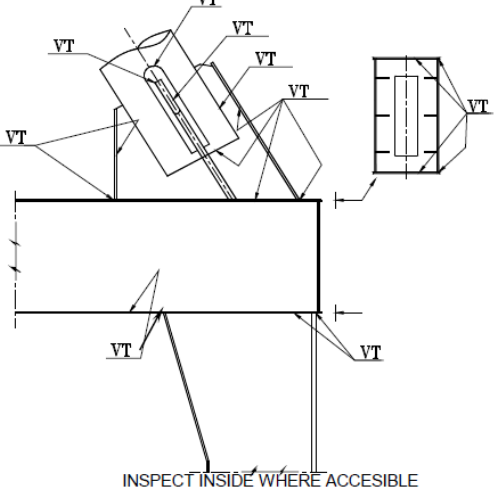
<p>INSPECT INSIDE WHERE ACCESSIBLE</p>	<p>VT gusset attachment weld legs 1 &amp; 2 at lower connection support beam need weld repair &amp; anchor attachment from diagonal support cable needs weld repair. WELD REPAIRED 10/12/22</p>

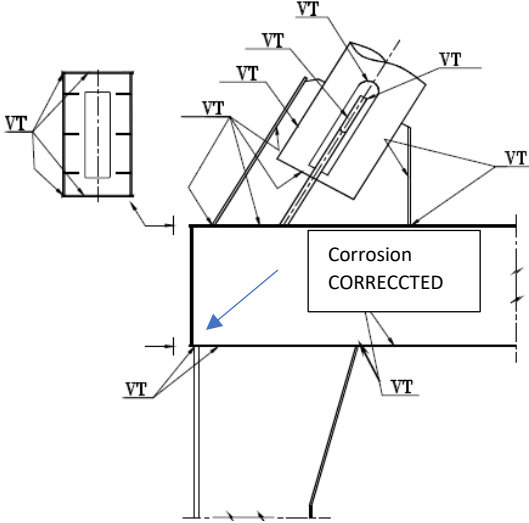
<p>M19-M20</p>

<p>Heavy corrosion on leg diagonal anchor for cable</p>
<p>Waterside Leg Girder Support Beam to Girder Connection</p>

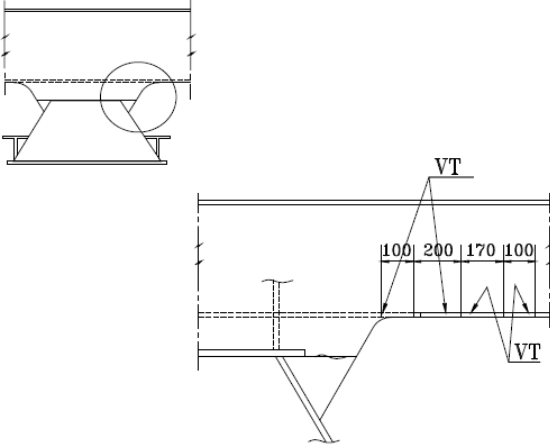
<div data-bbox="142 1357 338 1435" style="border: 1px solid black; padding: 2px; width: fit-content;"> <p>Reject-REAIRED 10/12/22</p> </div>	<p>VT 2 Accept</p>	<p>MT 0</p>

<p>Gusset plate weld needs weld repair, heavy corrosion.</p> <p>J-19-J-20</p>

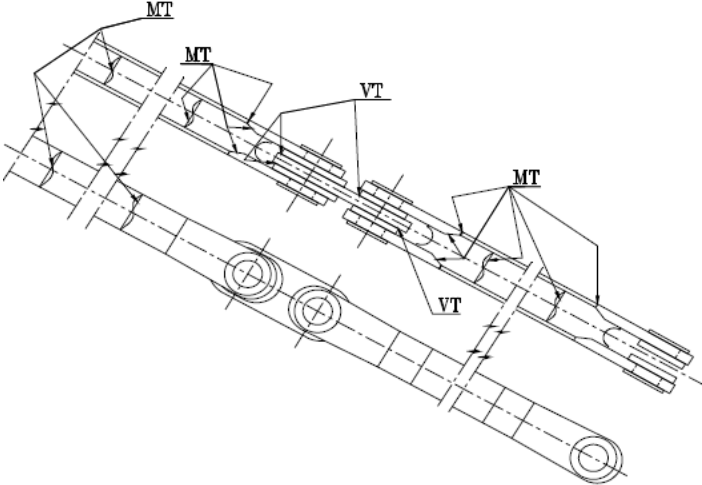
<p>M42-M47 Light surface corrosion at link plates</p>

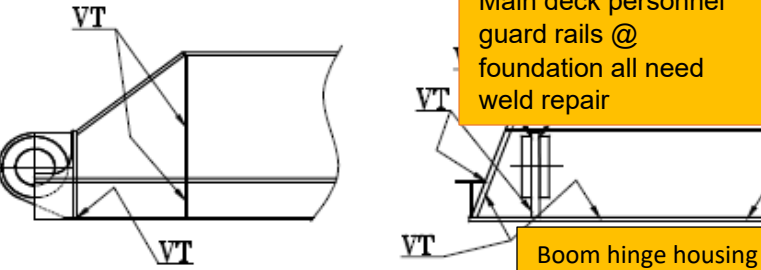
<p>Main deck personnel guard rails @ foundation all need weld repair</p> <p>Boom hinge housing attachment heavy corrosion</p>

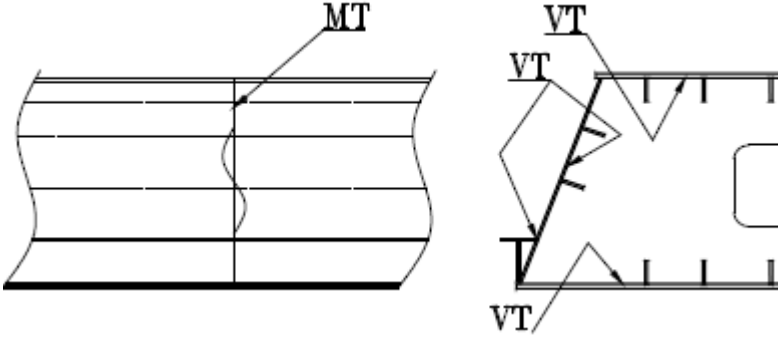
<div data-bbox="210 922 394 1019" style="background-color: yellow; border: 1px solid black; padding: 2px;">             Deck weld needs repair           </div>	VT 1-4 Accept all	MT 1 Accept all

J35 & J36 JB-B1AC JB-B2LC control station foundation welds need weld repair. Top deck splice weld heavy corrosion

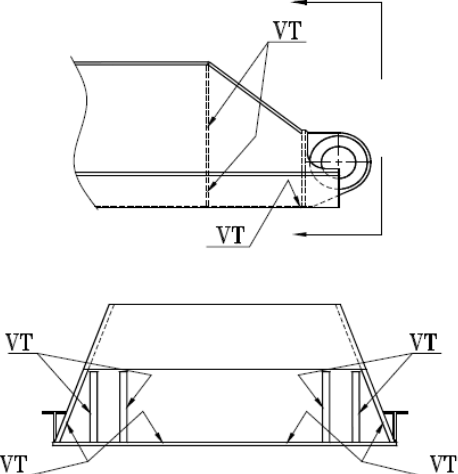
<p>M26 SDS structural inspection All girder platform bolt attachments have corrosion</p>

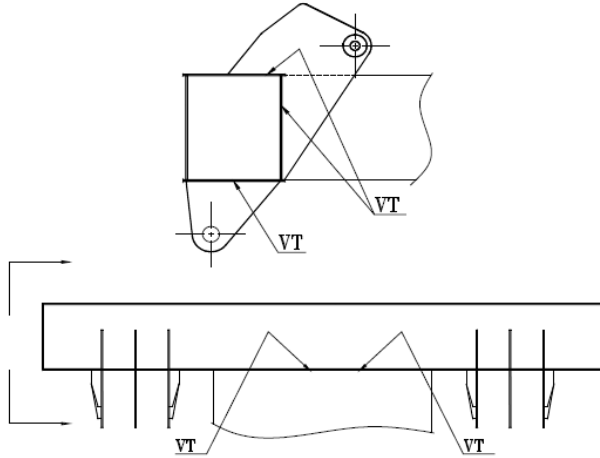
<div data-bbox="1297 1305 1556 1409" style="background-color: yellow; border: 1px solid black; padding: 5px;"> <p>Corrosion at tie ends</p> </div>

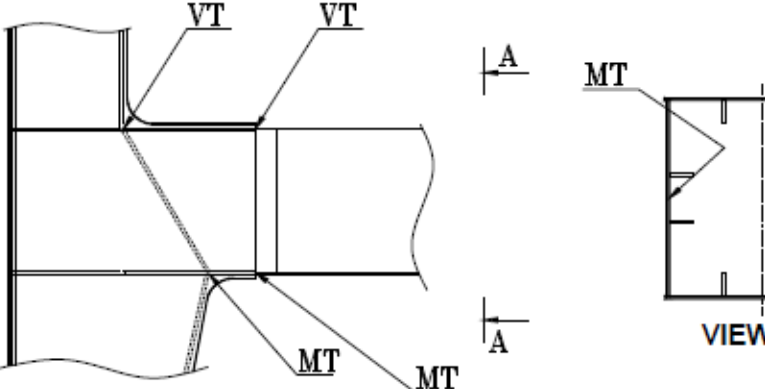
<p>ALL WELDS ARE VT UNLESS OTHERWISE NOTED</p>	<p>Man hole on leg 1 heavy corrosion at attachment weld M15-M16</p>
<p>Leg Diagonal (Part 1)</p>

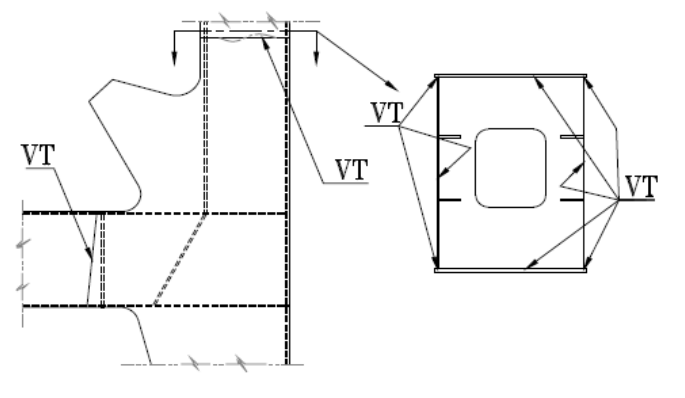
<p>VT reject on waterside leg #1 inside diameter plate material- CORRECTED 10/12/22</p>

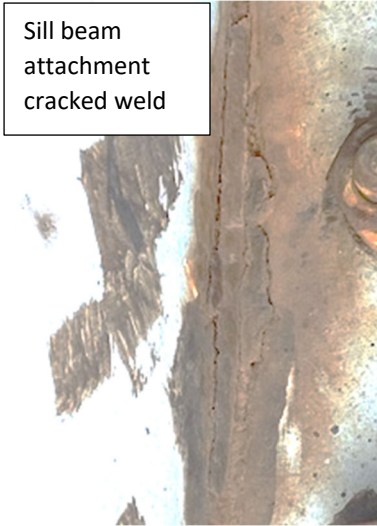
Sill beam attachment cracked weld

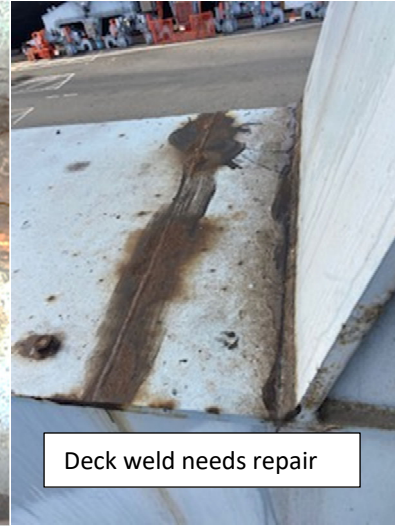
Deck weld needs repair
