## **ITS TERMINAL PACECO CRANE INSPECTION FORM** **MONO-BOX**

Crane serial Number: Crane 14 Leg Raise Outreach 177.2 ft Back Reach 75 ft Rail Span 100 ft

Inspected By: Scott Tucker Tucker's Technical Services

Date of Inspection: April 5,2022

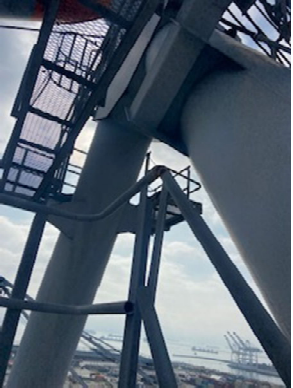
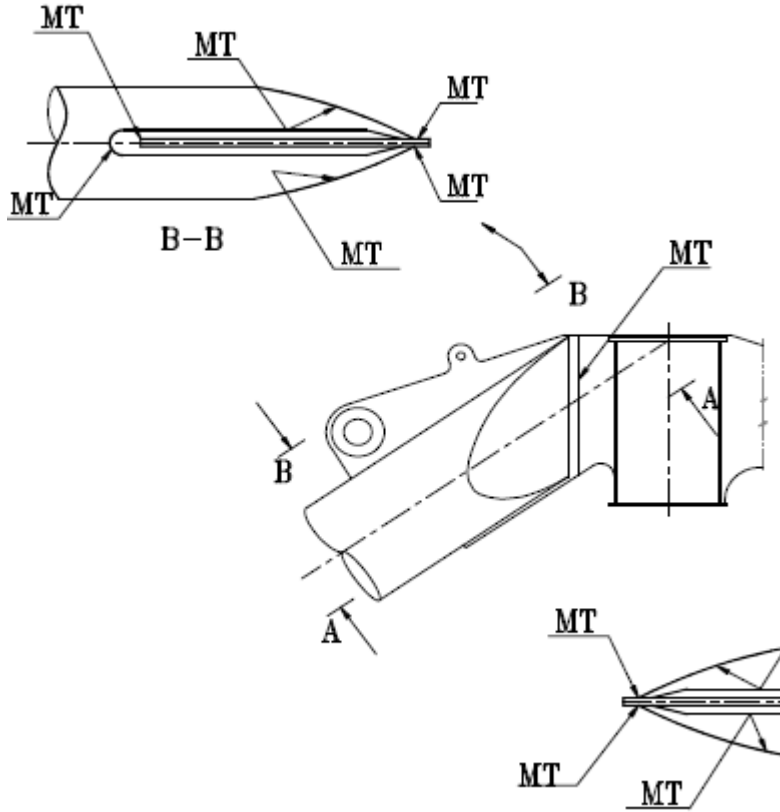
Part Name	VT	MT	Diagram	Inspector's Notes
<p>A-Frame Support (1)</p>

<p>VT 1 Accept all</p>	<p>MT 1- 15 Accept all</p>

<p>Accept all VT &amp; MT Points per B this section</p>

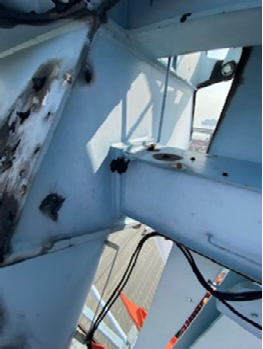
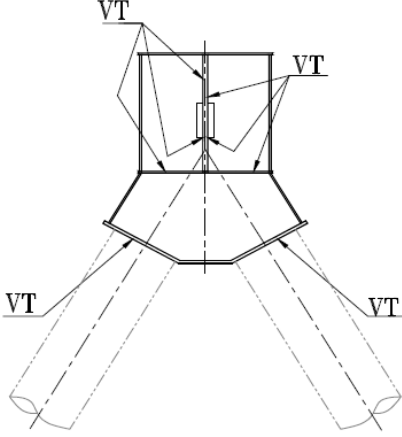
Part Name	VT	MT	Diagram	Inspector's Notes
<p>A-Frame &amp; Top Cross Connection</p>

<p>VT 1-4 Accept all</p>	<p>MT 0</p>

<p>J21-J24</p>

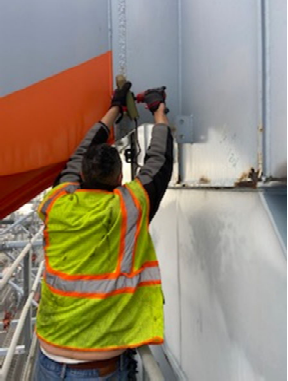
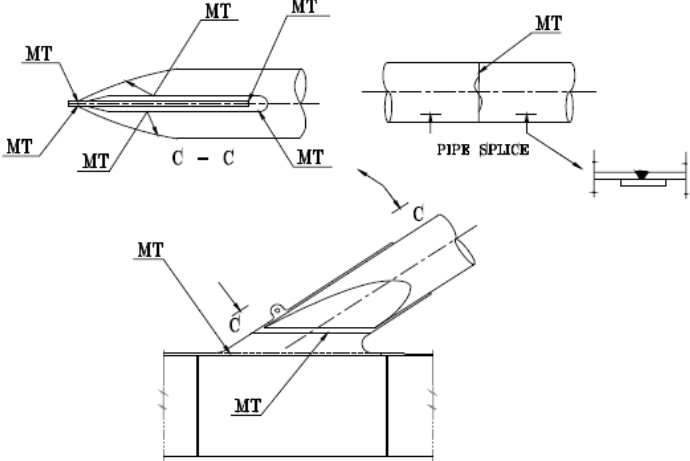
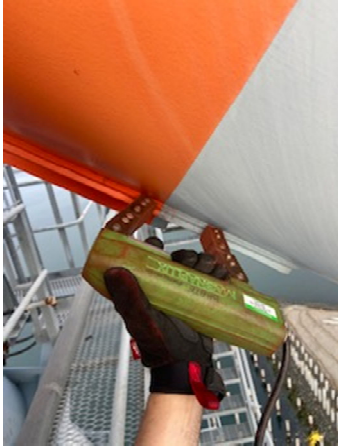
<p>VT 0</p>	<p>MT 1-8 Accept all</p>

<p>M21-</p> <p>M25</p>

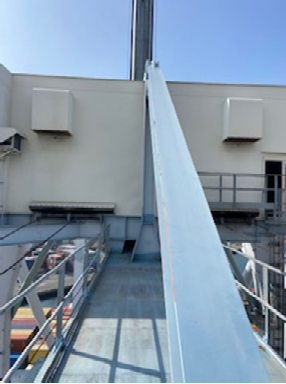
Part Name	VT	MT	Diagram	Inspector's Notes
<p>Backstay Support</p>

<p>VT 1-10 Accept all</p>	<p>MT 0</p>

<p>J42-J43 Back stay foundation welds Need weld repair</p> <p>Man hole next to back stay Attachment weld needs repair- WELD REPAIRED 10/12/22</p>

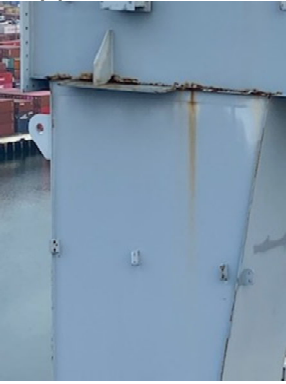
<p>Waterside Girder Support Beam</p>

<p>VT 1-9 Accept all WELD REPAIRED 10/12/22</p>	<p>MT 0</p>

<p>INSPECT INSIDE WHERE ACCESSIBLE</p>	<p>VT gusset attachment weld legs 1 &amp; 2 at lower connection support beam need weld repair &amp; anchor attachment from diagonal support cable needs weld repair. WELD REPAIRED 10/12/22</p>

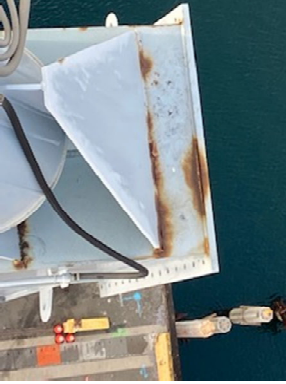
Part Name	VT	MT	Diagram	Inspector's Notes
<p>Waterside Leg Girder Support Beam</p>

<p>VT 1-9 Accept all</p>	<p>MT 0</p>

<p>M19-M20</p>

<p>Heavy corrosion on leg diagonal anchor for cable</p>
<p>Waterside Leg Girder Support Beam to Girder Connection</p>

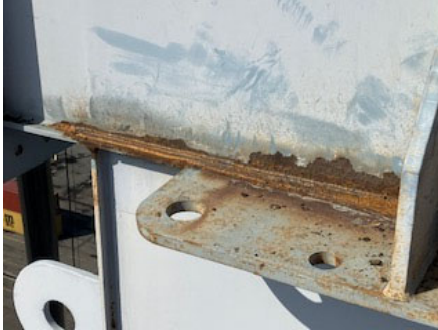
Part Name	VT	MT	Diagram	Inspector's Notes
Landside Leg Girder Support Beam to Girder Connection

VT 1-2 Accept all	MT 0

M13-M14
Landside Leg Girder Support Beam to A-Frame Connection

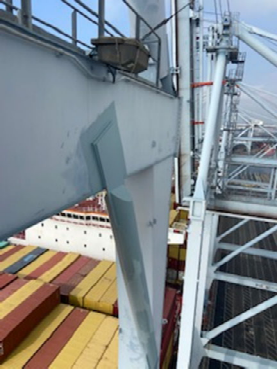
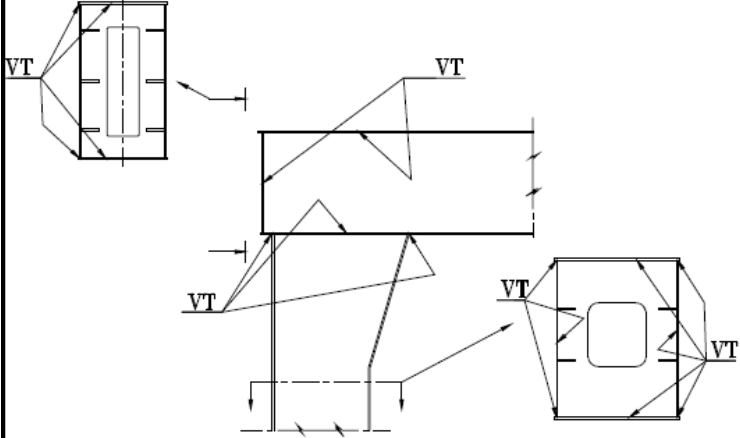
VT 1-5 Accept all	MT 0

M19-M22

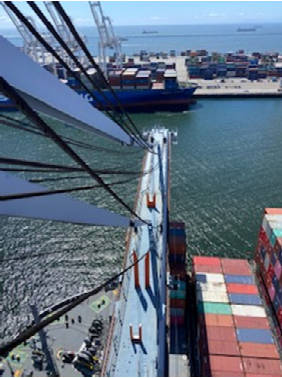
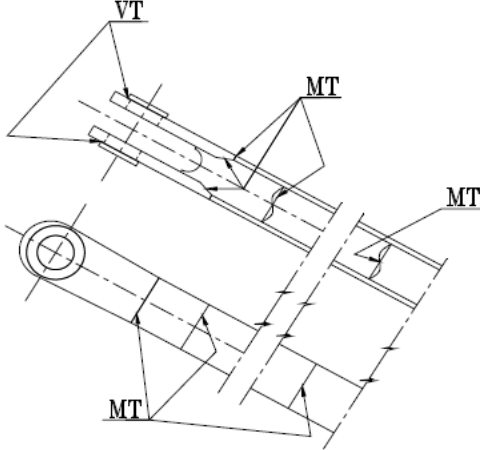
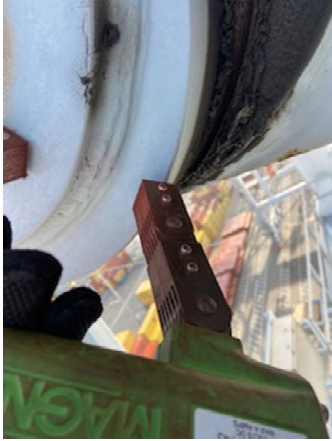
Part Name	VT	MT	Diagram	Inspector's Notes
<p>Outer Forestay Upper Section</p>

<p>VT 1 Accept all</p>	<p>MT 1-3 Accept all</p>

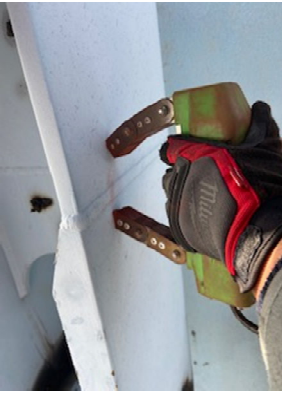
<p>Outer Forestay Middle Link</p>

<p>VT 1-2 Accept all</p>	<p>MT 1-3 Accept all</p>

<p>M42-M47 Light surface corrosion at link plates</p>

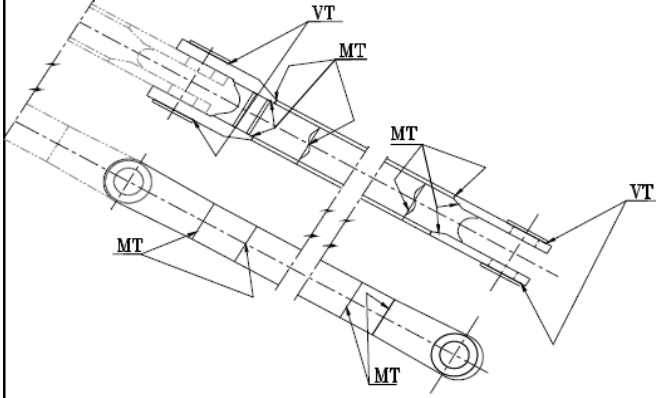
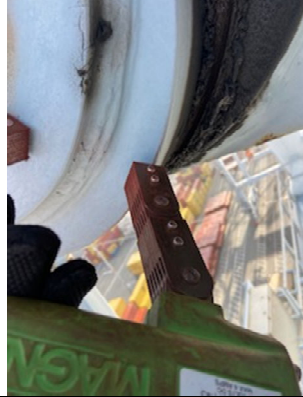
Part Name	VT	MT	Diagram	Inspector's Notes
Outer Forestay Lower Link

VT 1-2 Accept all	MT 1-4 Accept all

M42-M47

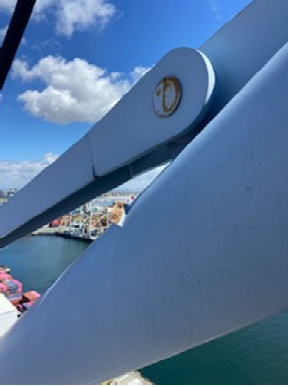
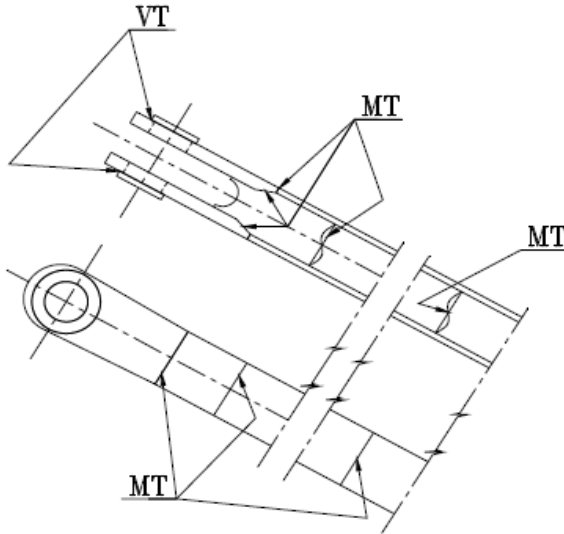
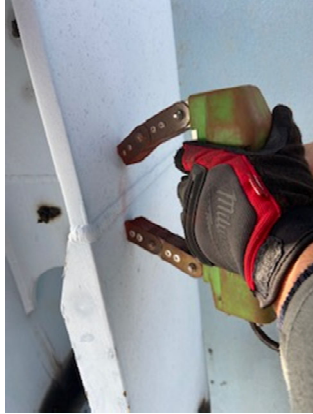
Inner Forestay Upper Link

VT 1 Accept all	MT 1-3 Accept all

M36- M41

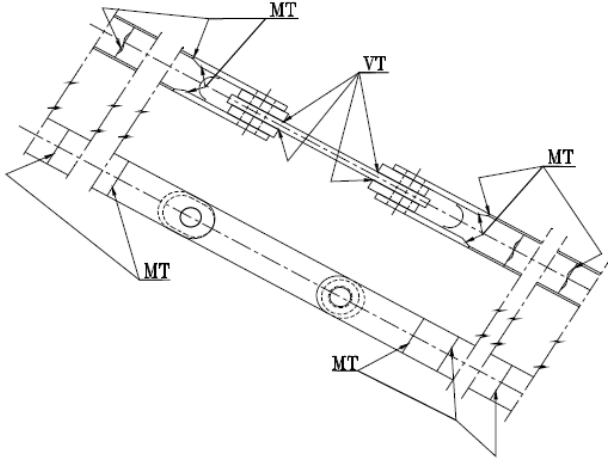
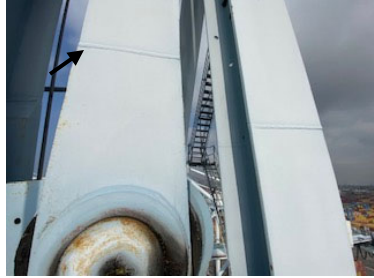
Part Name	VT	MT	Diagram	Inspector's Notes
Inner Forestay Middle Link

VT 1 Accept all	MT 1-4 Accept all

M40, M39, M44, M43
Inner Forestay Lower Link

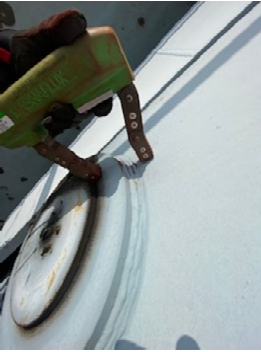
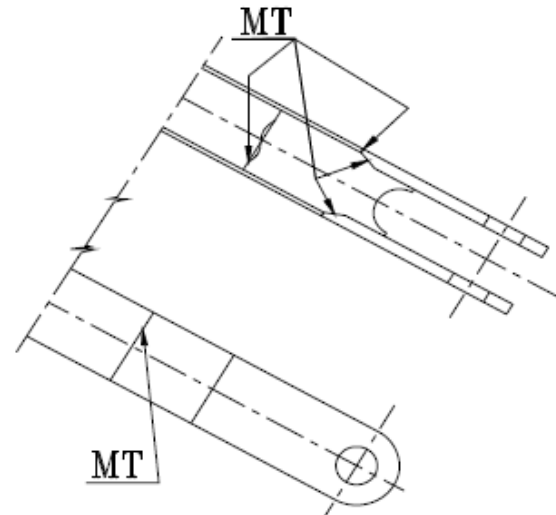
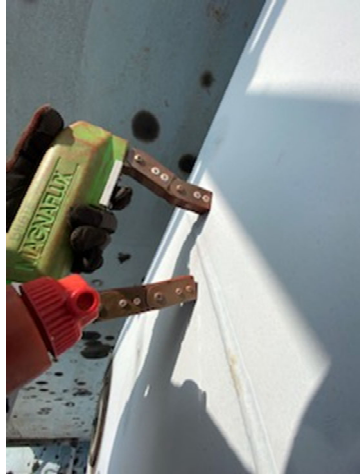
VT 0	MT 1-2 Accept all

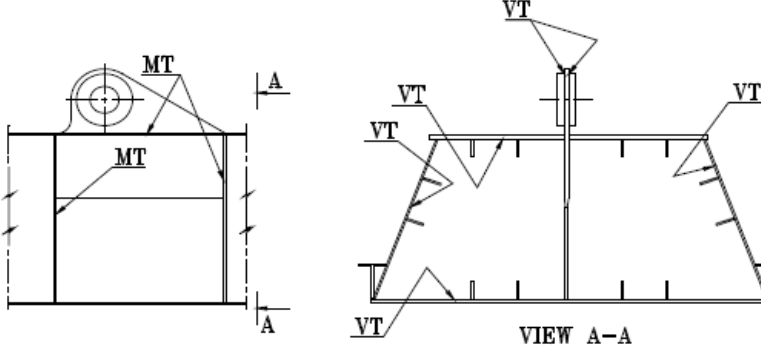
Part Name	VT	MT	Diagram	Inspector's Notes
Inner Forestay Bracket

VT 1-5 Accept all	MT 1-2 Accept all

M36

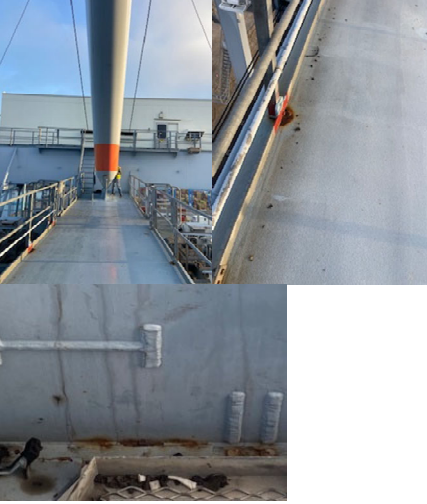
Boom Hinge

VT 1-8 Accept all	MT 0

<p>Main deck personnel guard rails @ foundation all need weld repair</p> <p>Boom hinge housing attachment heavy corrosion</p>

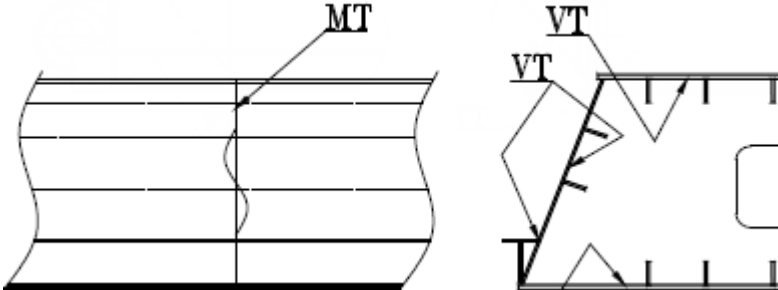
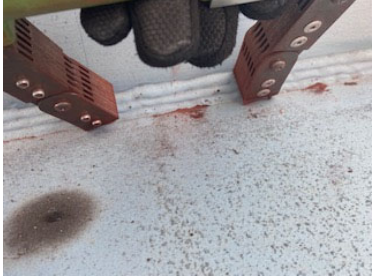
Part Name	VT	MT	Diagram	Inspector's Notes
Trolley Girder Section @ Splice

VT 1-4 Accept all	MT 1 Accept all

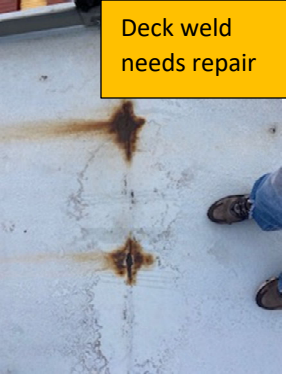
Boom Section @ Splice

<div data-bbox="210 922 394 1019" style="background-color: yellow; border: 1px solid black; padding: 2px;">             Deck weld needs repair           </div>	VT 1-4 Accept all	MT 1 Accept all

J35 & J36 JB-B1AC JB-B2LC control station foundation welds need weld repair. Top deck splice weld heavy corrosion

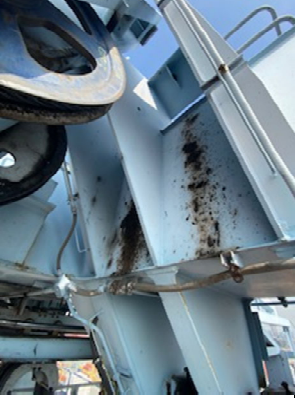
Part Name	VT	MT	Diagram	Inspector's Notes
<p>Trolley Girder Hinge</p>

<p>VT 1-6 Accept all</p>	<p>MT 0</p> <p>M26-M28</p>

<p>M26 SDS structural inspection All girder platform bolt attachments have corrosion</p>

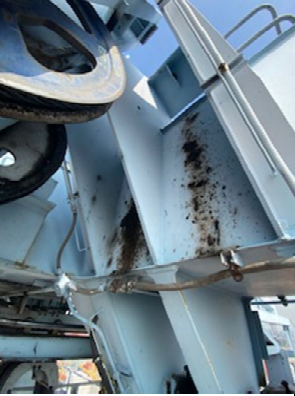
<p>Trolley Girder End Tie</p>

<p>VT 1-4 Accept all</p>	<p>MT0</p> <p>J-37</p>

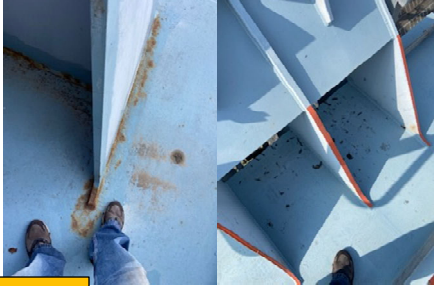
<div data-bbox="1297 1305 1556 1409" style="background-color: yellow; border: 1px solid black; padding: 5px;"> <p>Corrosion at tie ends</p> </div>

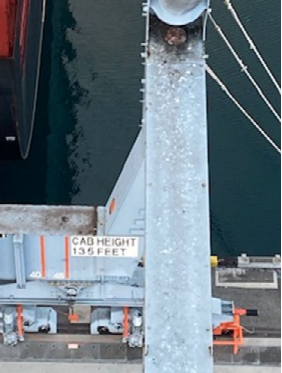
Part Name	VT	MT	Diagram	Inspector's Notes
<p>Portal Tie Landside</p>

<p>VT 1-2 Accept all</p>	<p>MT 1-4 Accept all</p>

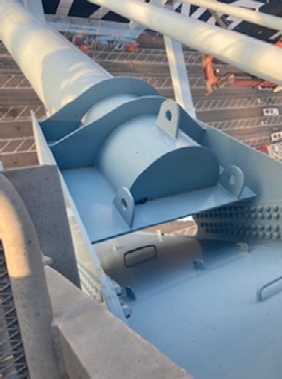
<p>ALL WELDS ARE VT UNLESS OTHERWISE NOTED</p>	<p>Man hole on leg 1 heavy corrosion at attachment weld M15-M16</p>
<p>Leg Diagonal (Part 1)</p>

<p>VT 1-22 Accept all</p>	<p>MT 1 Accept all</p>

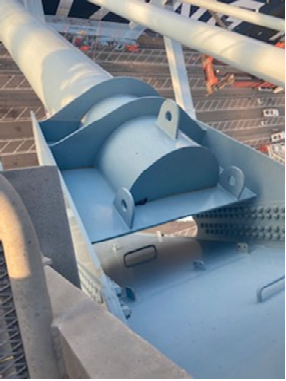
Part Name	VT	MT	Diagram	Inspector's Notes
<p>Leg Diagonal (Part 2)</p>

<p>VT 1-22 Accept all</p>	<p>MT 1 Accept all</p>	<p>ALL WELDS ARE VT UNLESS OTHERWISE NOTED</p>

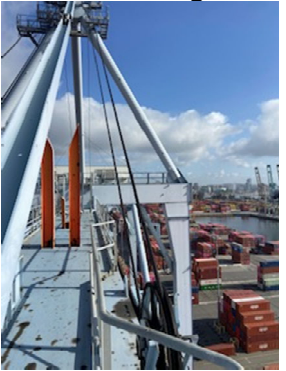
<p>VT 1-4 Accept all</p>	<p>MT 0  M11- M12</p>

<p>VT reject on waterside leg #1 inside diameter plate material- CORRECTED 10/12/22</p>

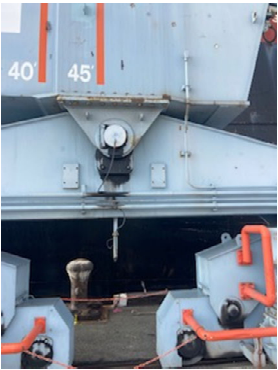
Part Name	VT	MT	Diagram	Inspector's Notes
<p>Sill beam</p>

<p>VT 1-5 Accept all</p> <p>VT 6 ACCEPT POST WELD REPAIR 10/12/22</p>	<p>MT 0</p> <p>M-5- M6</p>

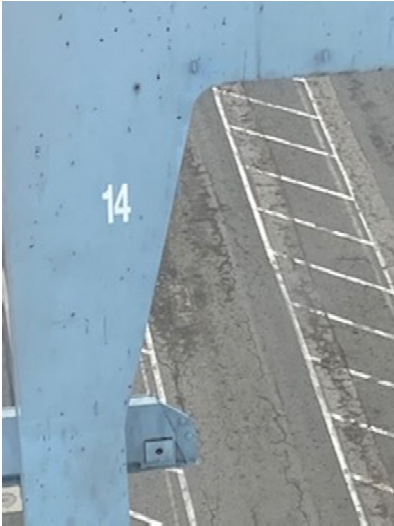
Sill beam attachment cracked weld

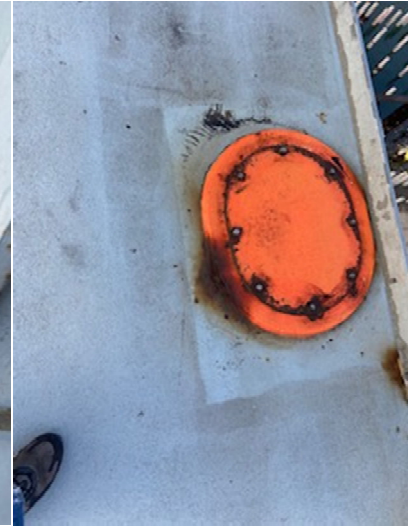
Deck weld needs repair

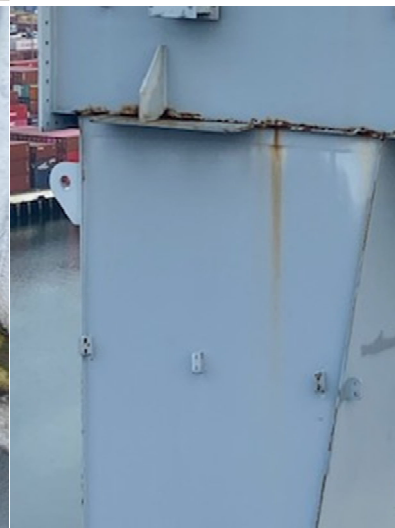
<p>Four corner connection gusset plate heavy corrosion</p>
<p>A-Frame Support Lower</p>

Four corner connection
